ROMANIAN NAVAL AUTHORITY

REPORT

ON THE INVESTIGATION OF THE INCIDENT M/V “GULIZAR ANA”, SEPTEMBER 2006

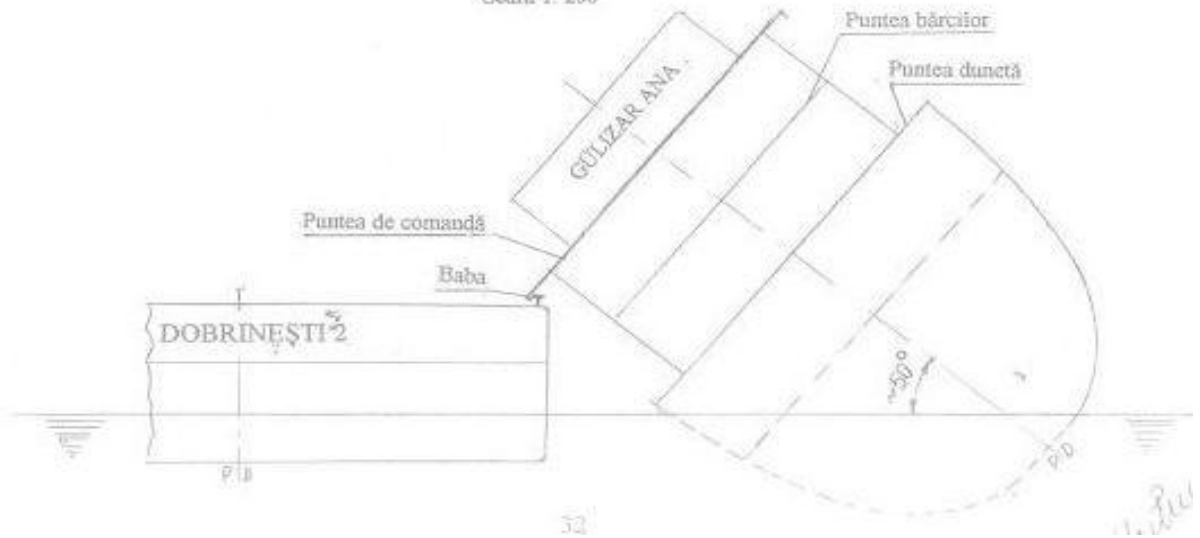
Nava după înclinare cu cca. 50° în
bordul tribord și sprijinire cu puntea
de comandă pe bazele de la pupa
a macaralei „DOBRINEȘTI 2”

Vessel berthing position and vessel's position after lean , about 50°list

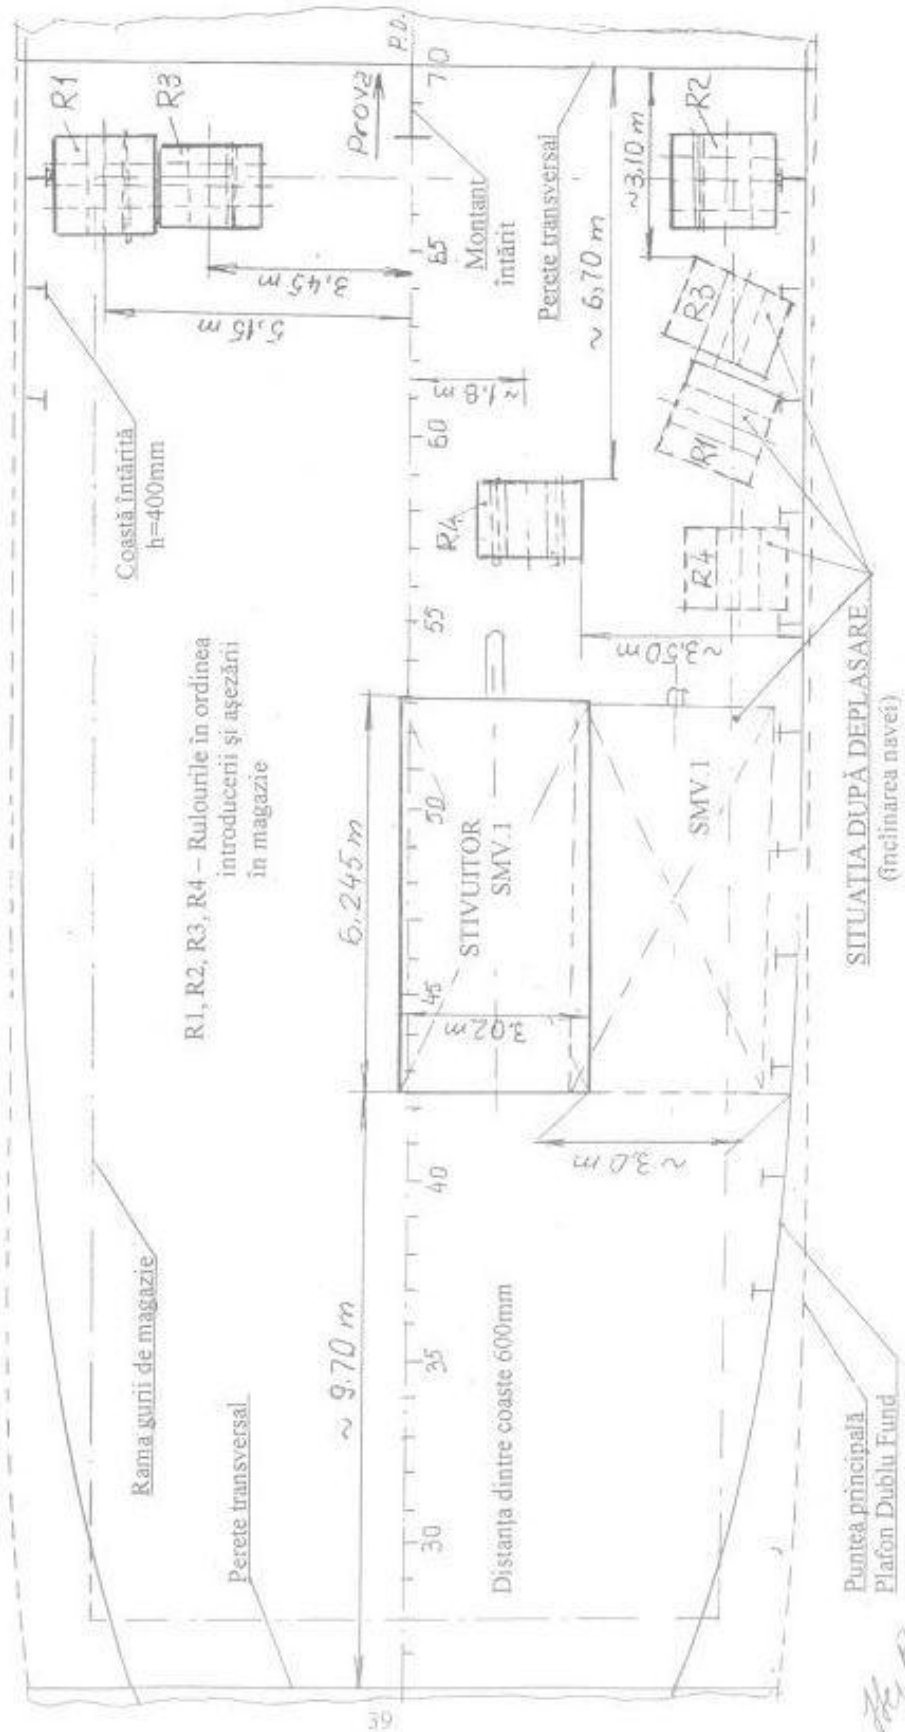
M/V „GŪLIZAR ANA” – MAGAZIA NR. 2
 POZIȚIA RULOUIRILOR ȘI STIVUITORULUI ÎNAINTE ȘI DUPĂ DEPLASARE ȘI ÎNCLINAREA
 NAVEI LA DATA de 09.09.2006 ora:21,00
 Conform declarațiilor echipajului navei
 Scara 1:100

Hold nr.2 - coils and forklift position before and after leaning

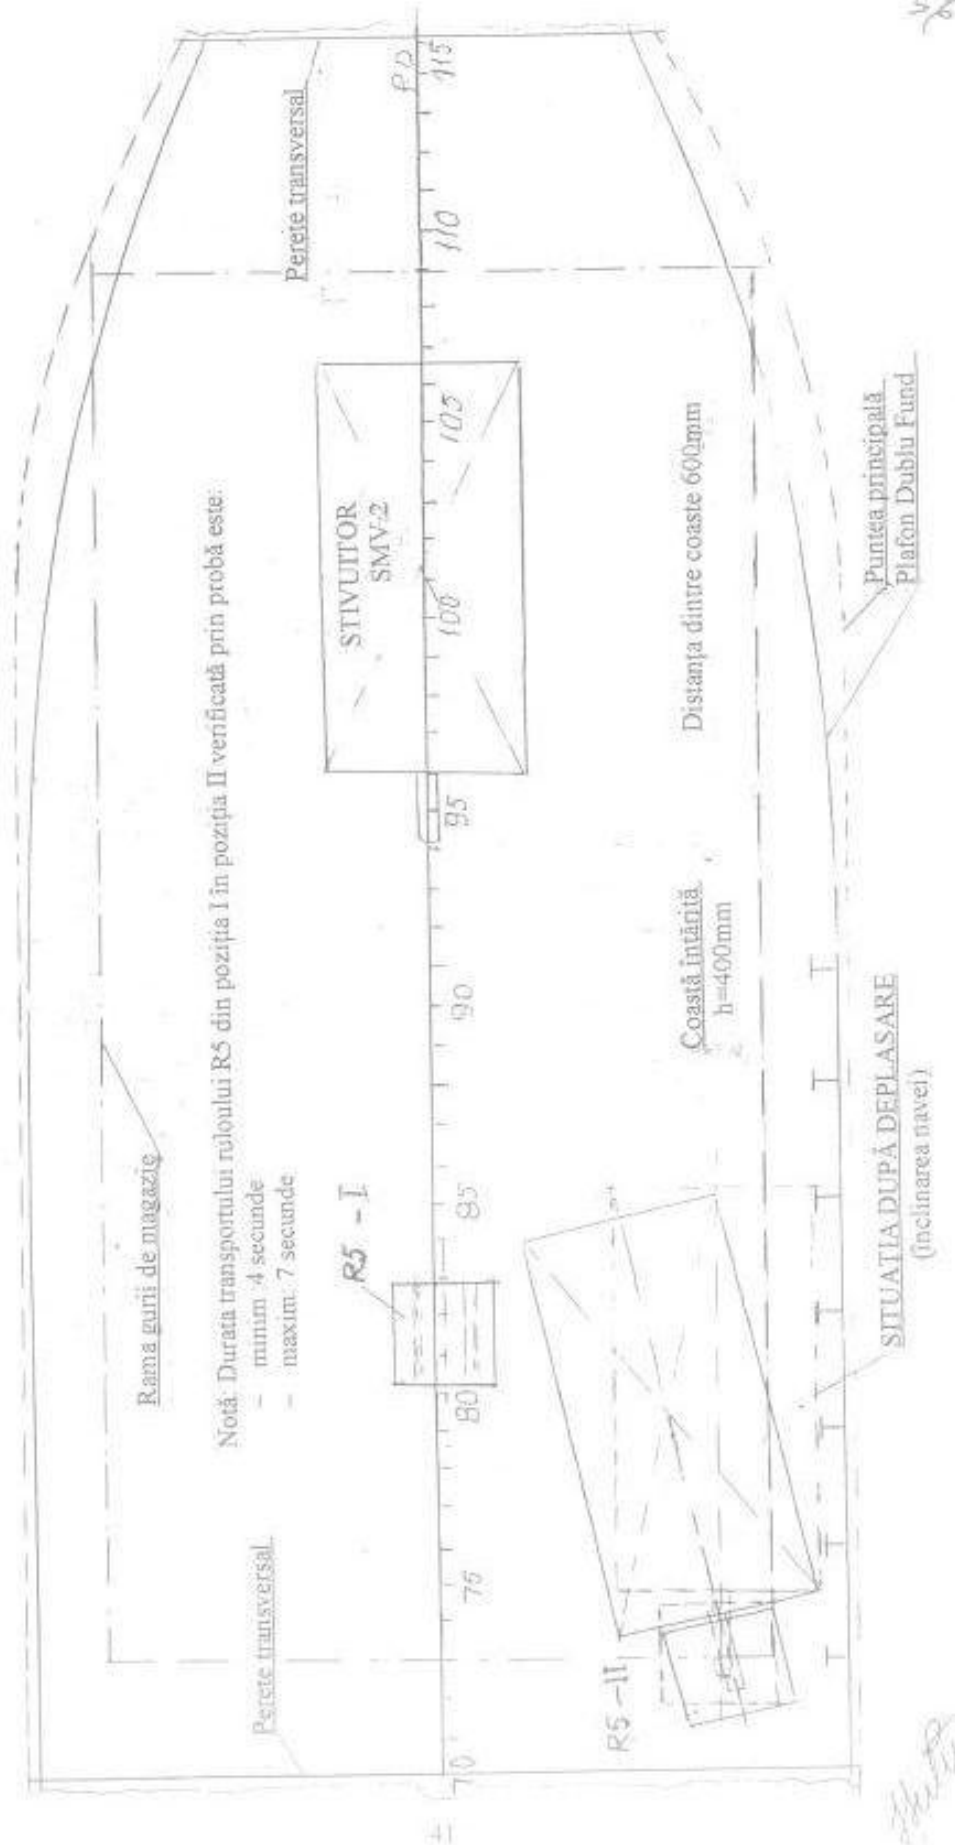
M/V „GŪLIZAR ANA” – MAGAZIA NR.1
POZIȚIA RULOLUI R5 ȘI STIVUITORUL ÎNAINTE ȘI DUPĂ DEPLASARE ȘI ÎNCLINAREA
 NAVEI LA DATA de 09.09.2006 ora: 21,00
 Conform declarațiilor echipajului navei și stivatorilor.
 Scara 1:100

Hold nr.1 - coil and forklift position before and after leaning

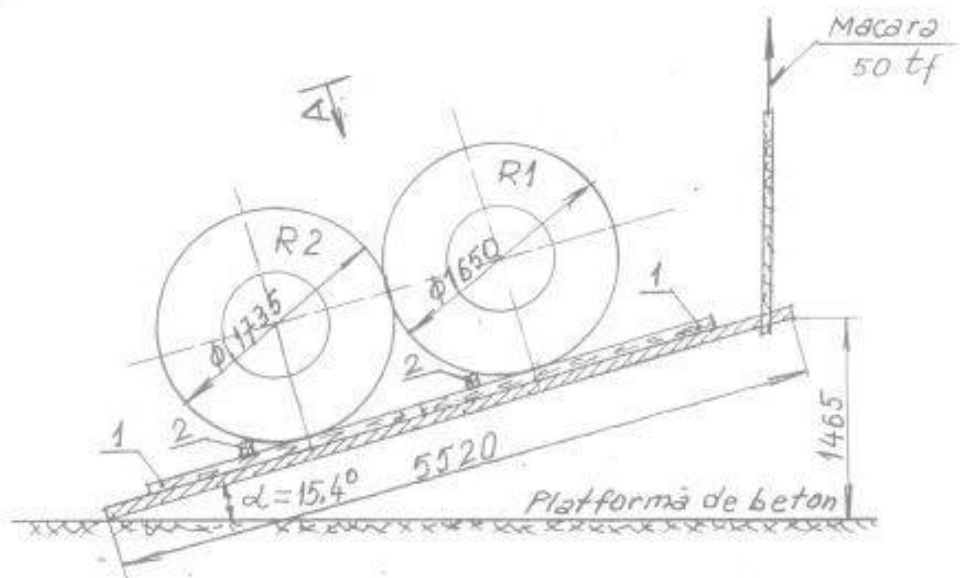
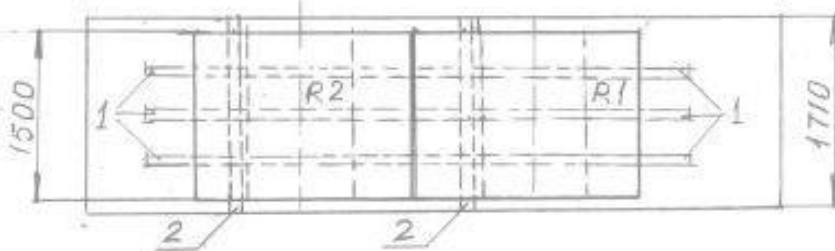
DETERMINAREA UNGHIIULUI DE INCLINARE
LA DEPLASAREA RULOUIRILOR

1. temporary fixing of steel coils by wood wedge , not efficint at a list greater than 15 degree ;
2. maximum angle of vessel's stability during loading – 25 degree ;
3. at a list of 44 degree the river water has flooded in to crew quarter through the windows ;
4. engine room flooded through an emergency exit hatch , left opened, increasing the vessel's list.

Determination of list angle when coils start shifting

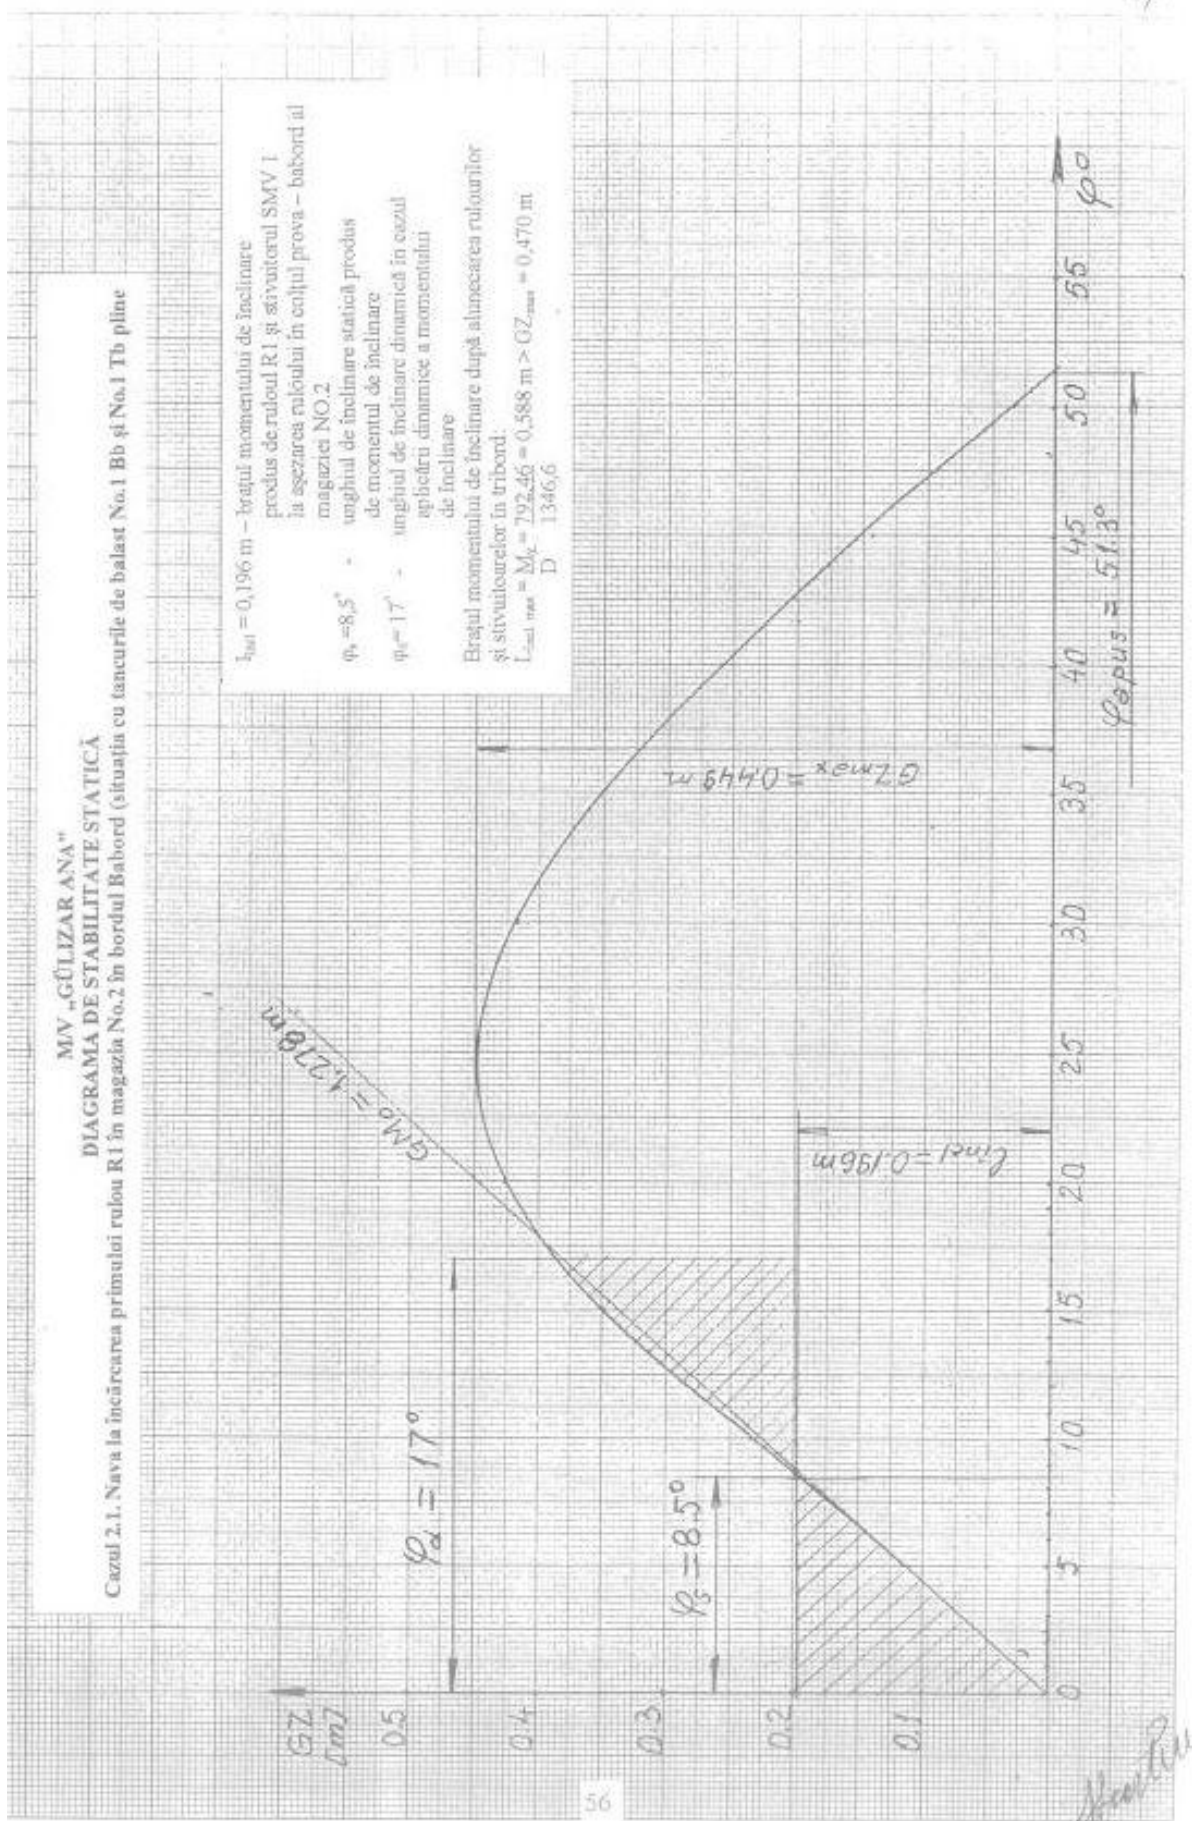
Stability diagram before loading

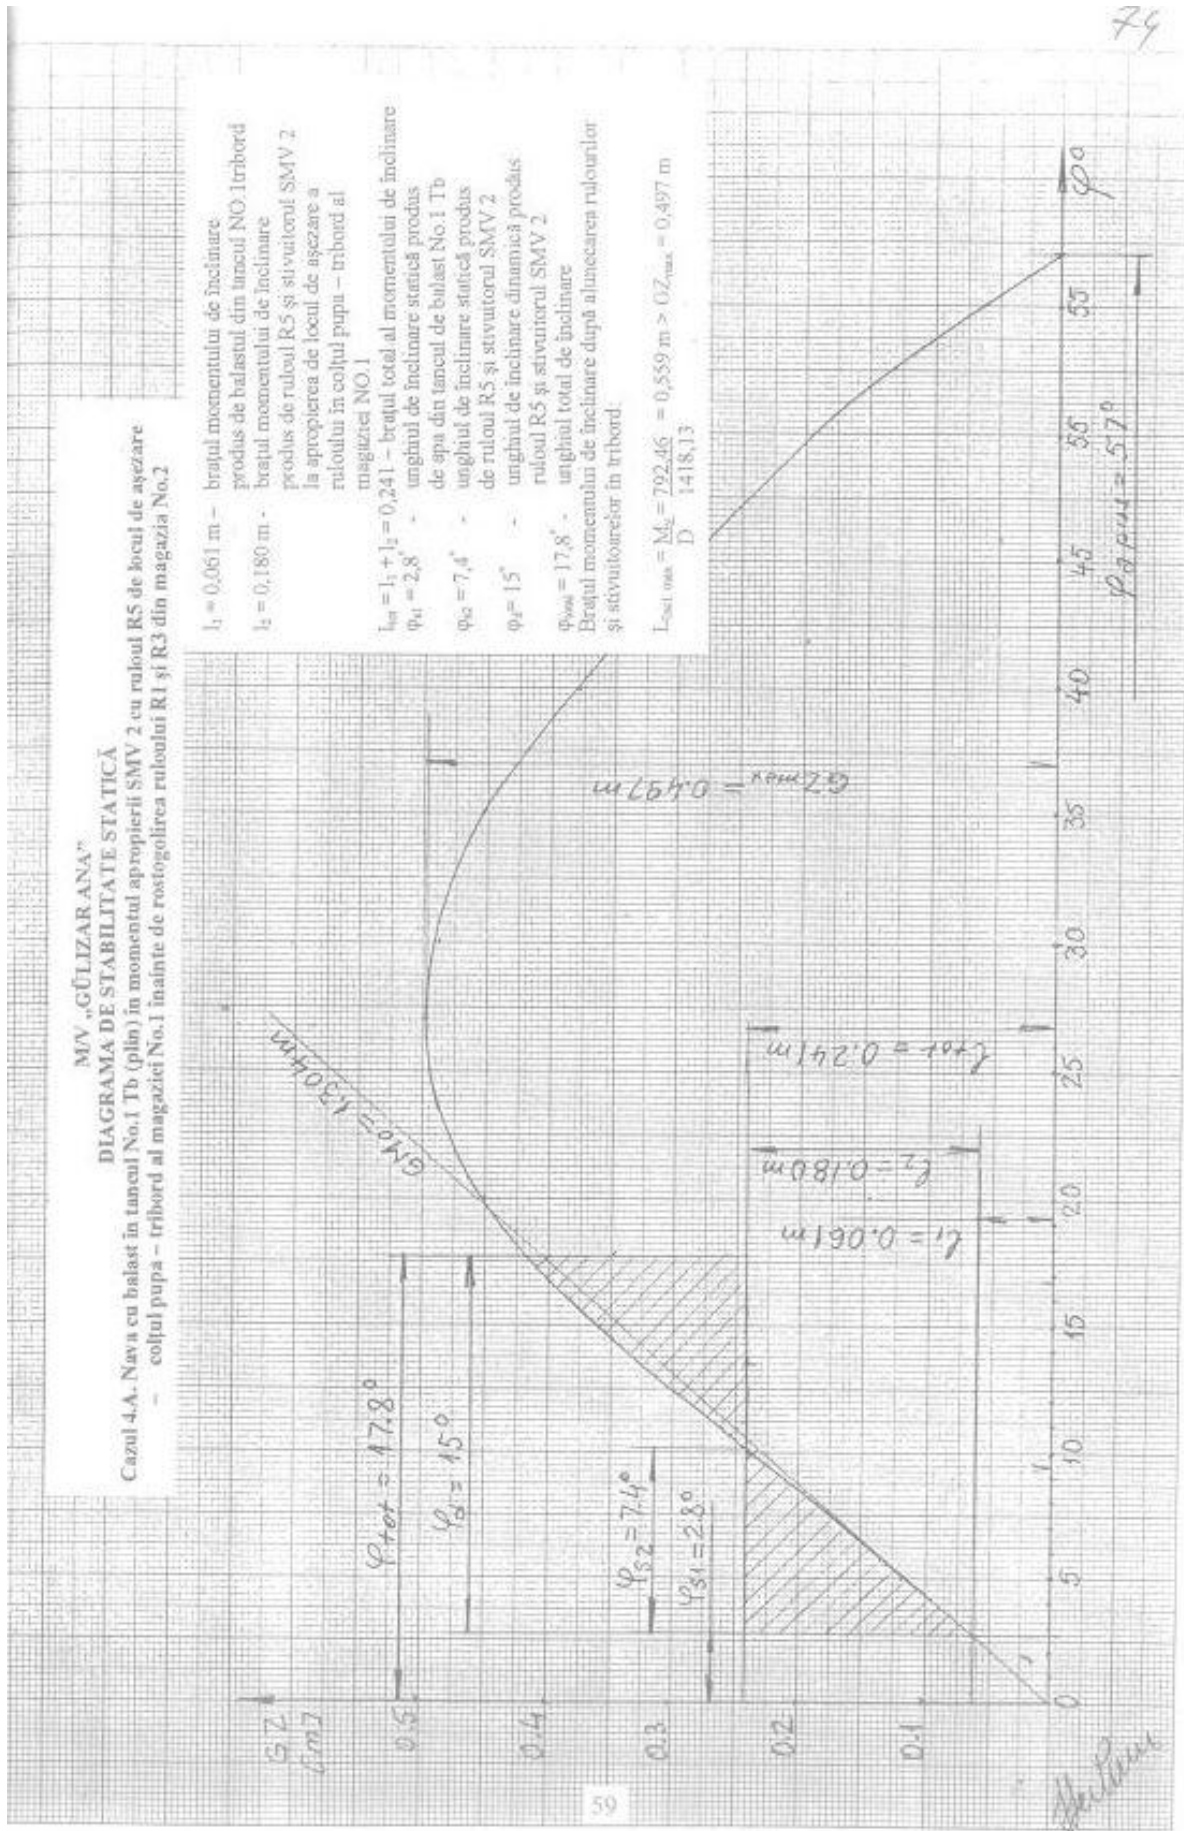
Stability diagram after loading of coil no.5

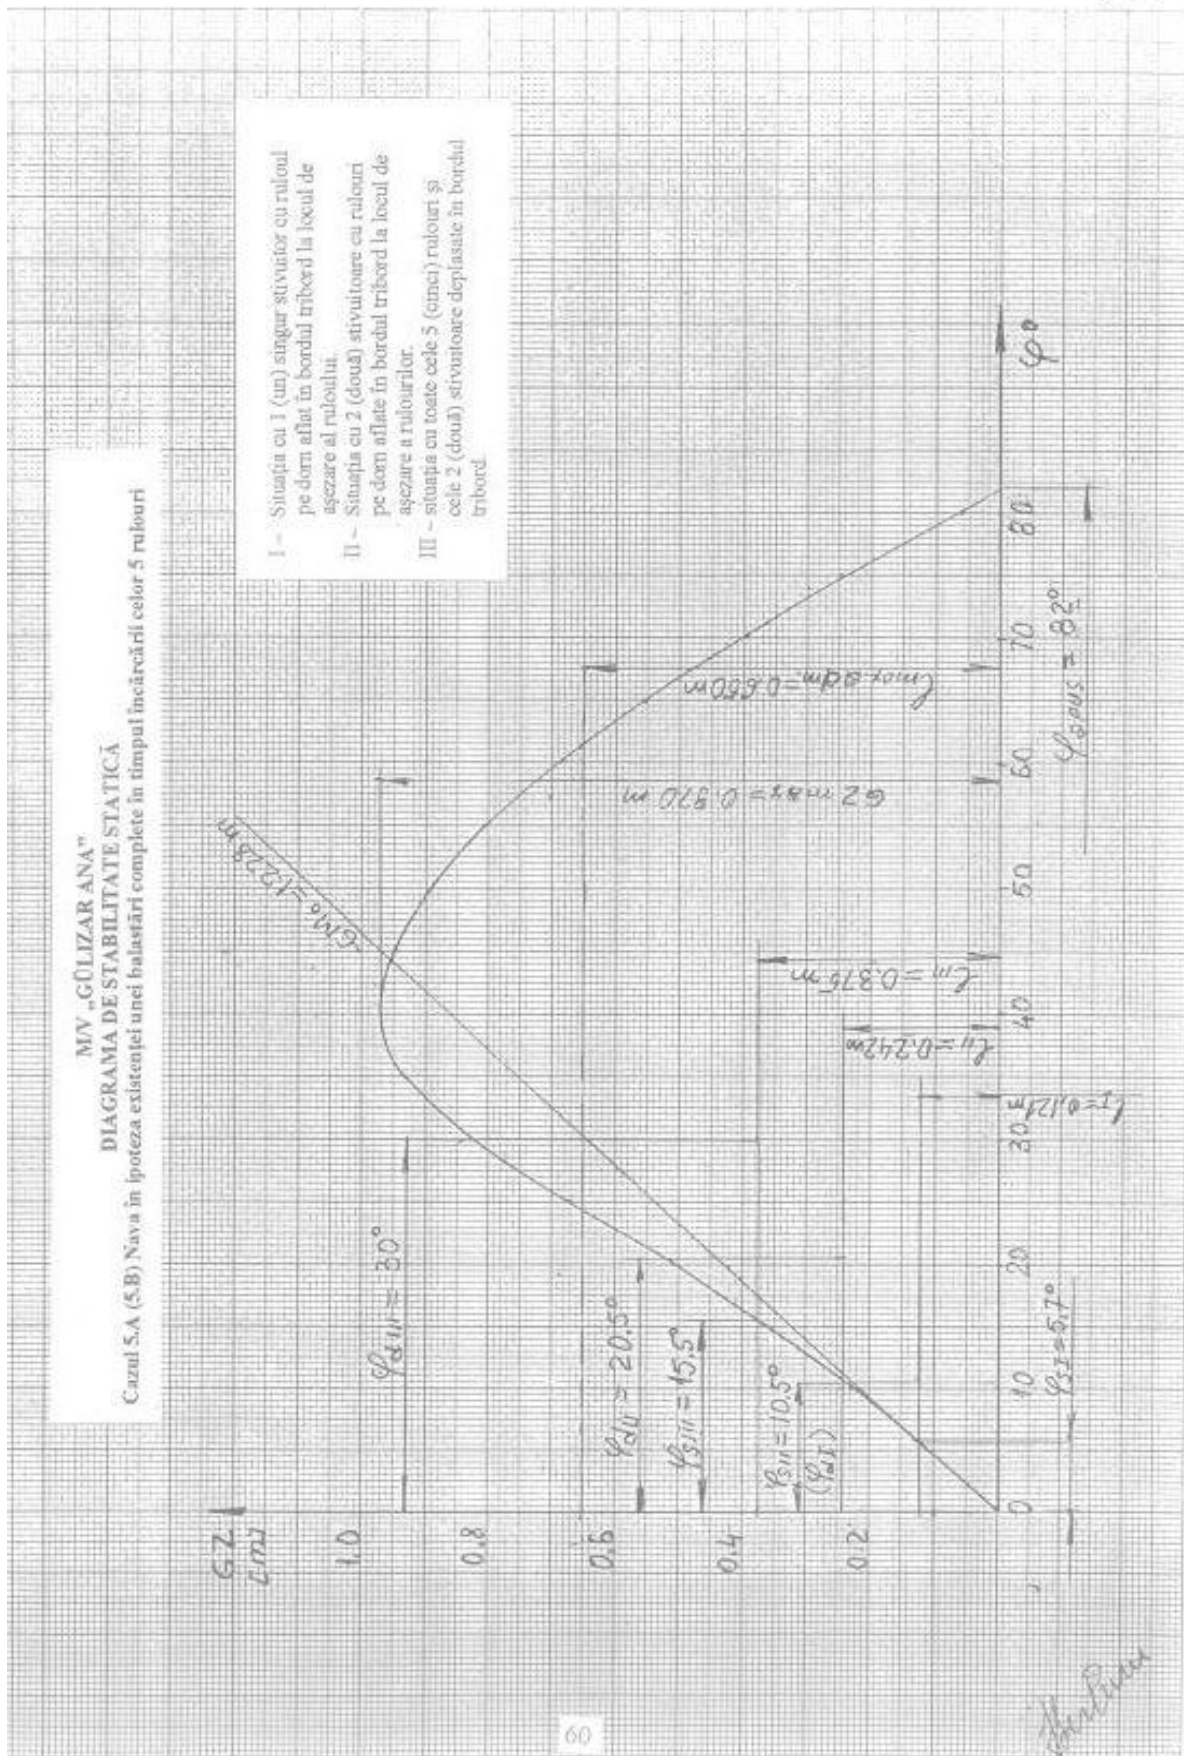
Compared stability diagram during loading
