ROMANIAN NAVAL AUTHORITY

REPORT

ON THE INVESTIGATION OF THE INCIDENT M/V “GULIZAR ANA”, SEPTEMBER 2006

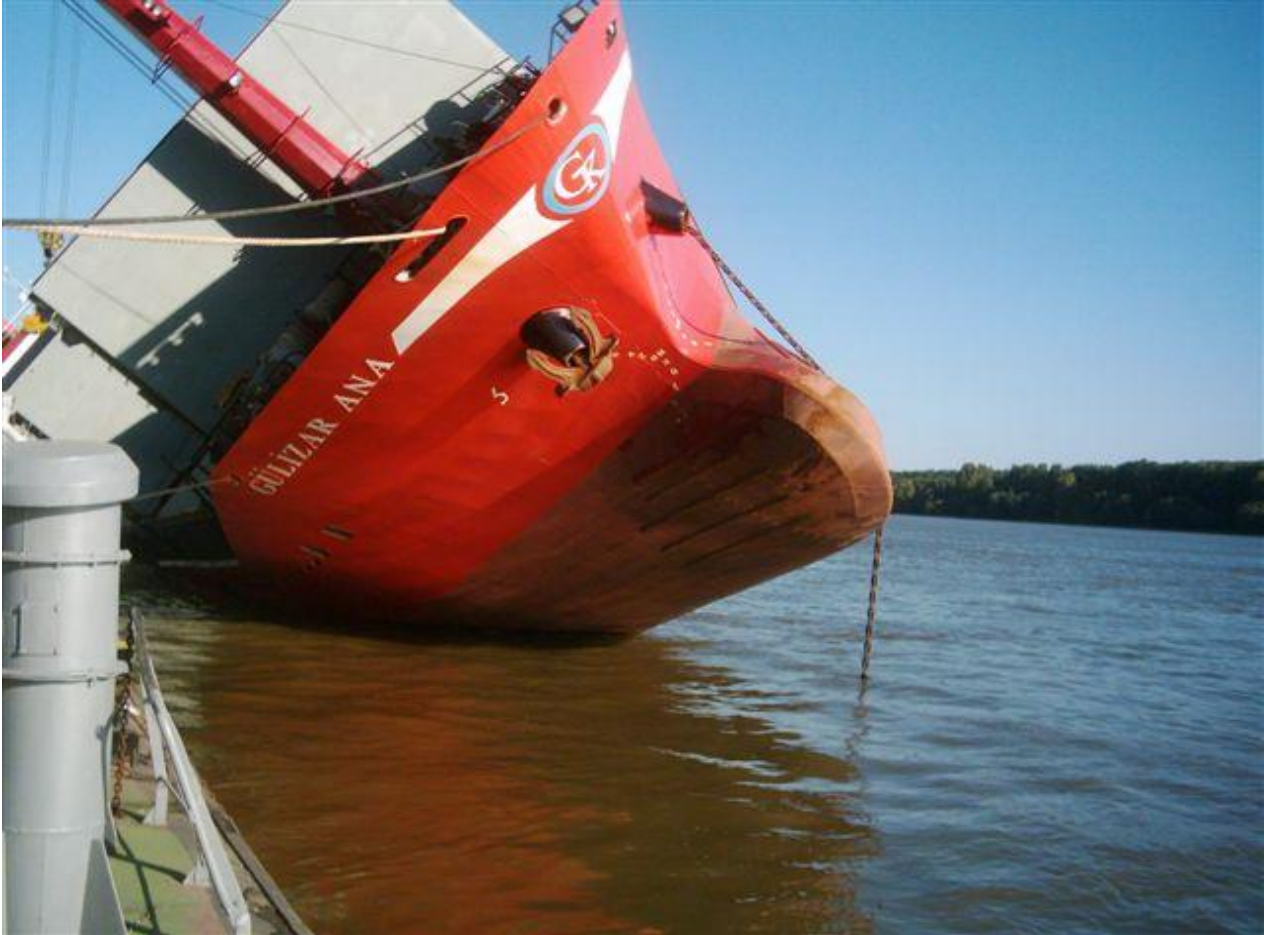
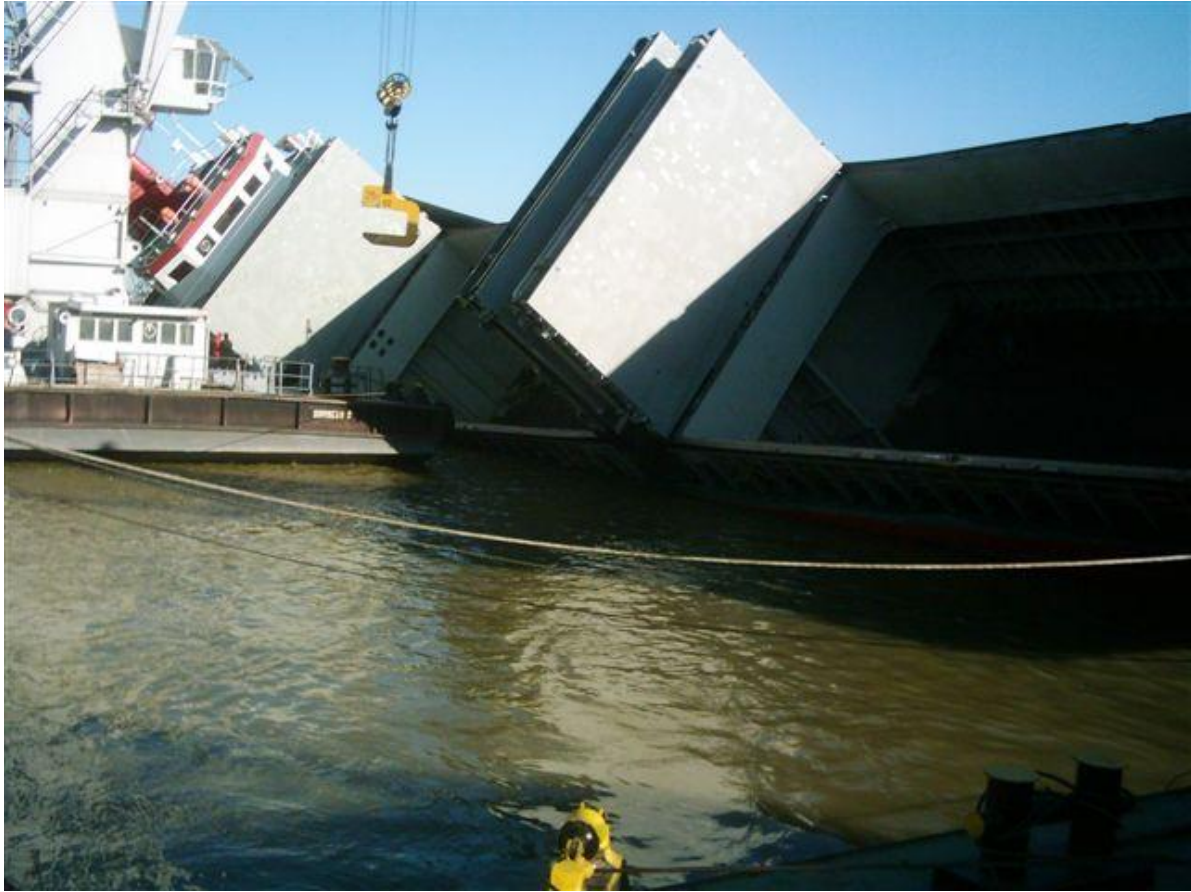
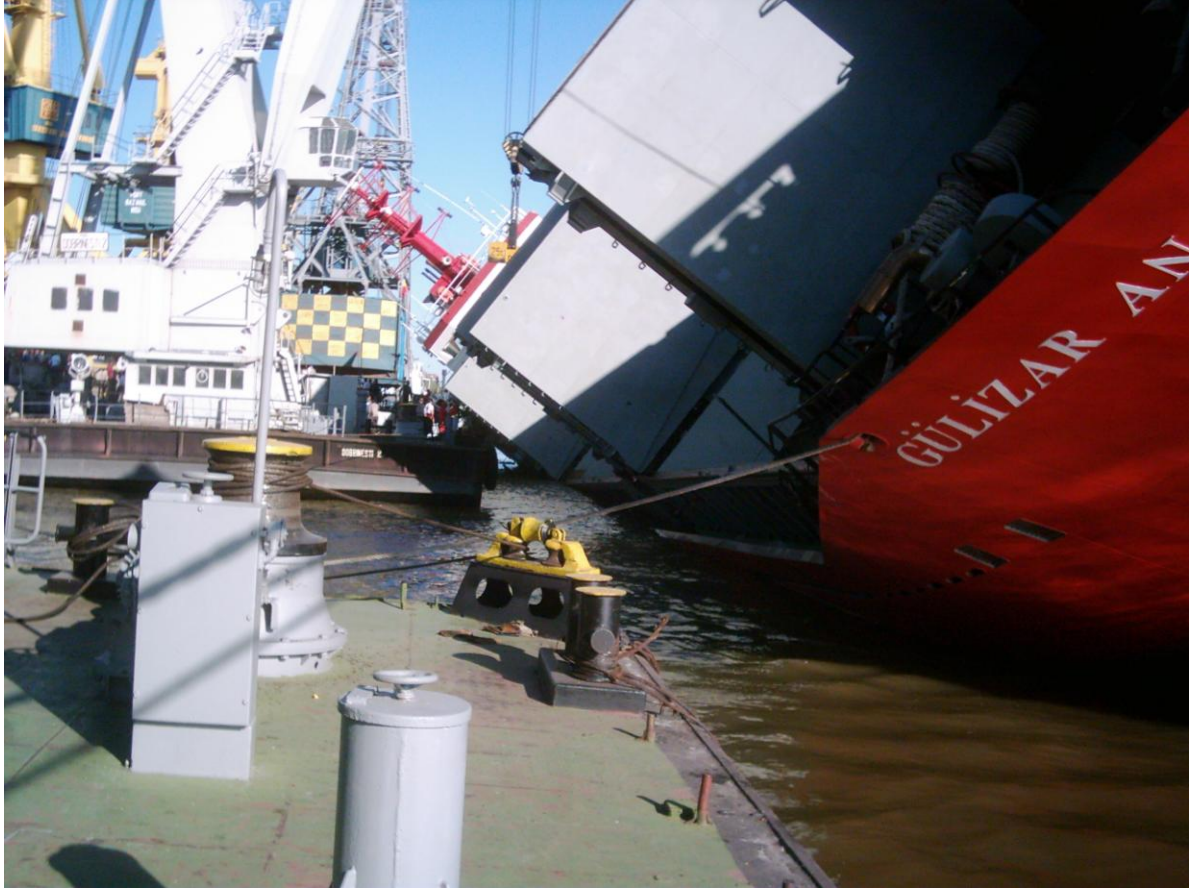
After loading of 5th steel coils on 9th September at 20.55 hrs/lt vessel began to lean on starboard side till the vessel’s accommodation has propped on main deck of floating crane “Dobrinesti 2”

Immediately after the incident, four steel coils have been discharged and rescue operation started. All openings of engine room and crew quarter were sealed and the water pumped out.

On 21st September 2006 rescue operations have been completed and vessel brought on seaworthiness condition.
